GUIDELINES FOR CONSERVATION OF HERITAGE PROPERTIES OF LAND IN CUENCA

4. DAMAGE AND CONSERVATION OF EARTH BUILDINGS

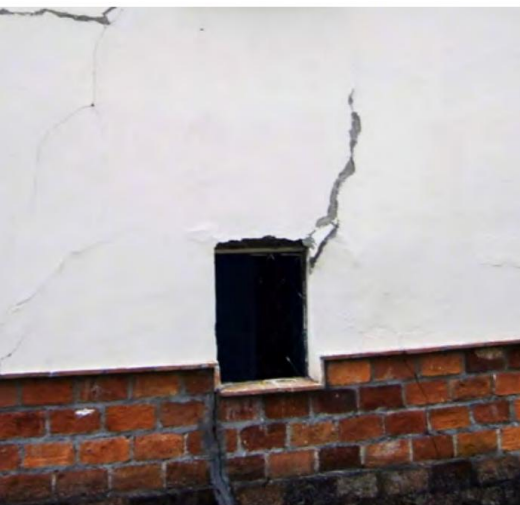
Little embedment of the lintels (LA)

There is no vertical lock (CP)

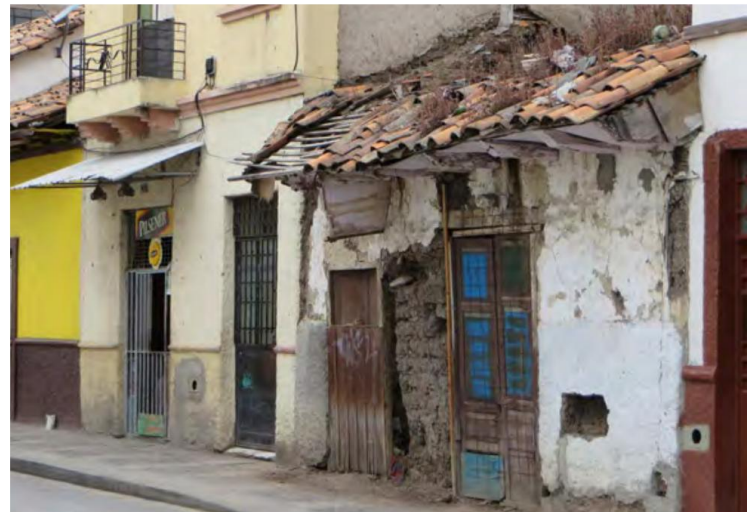
Ruined building in the Historic Center (ES)

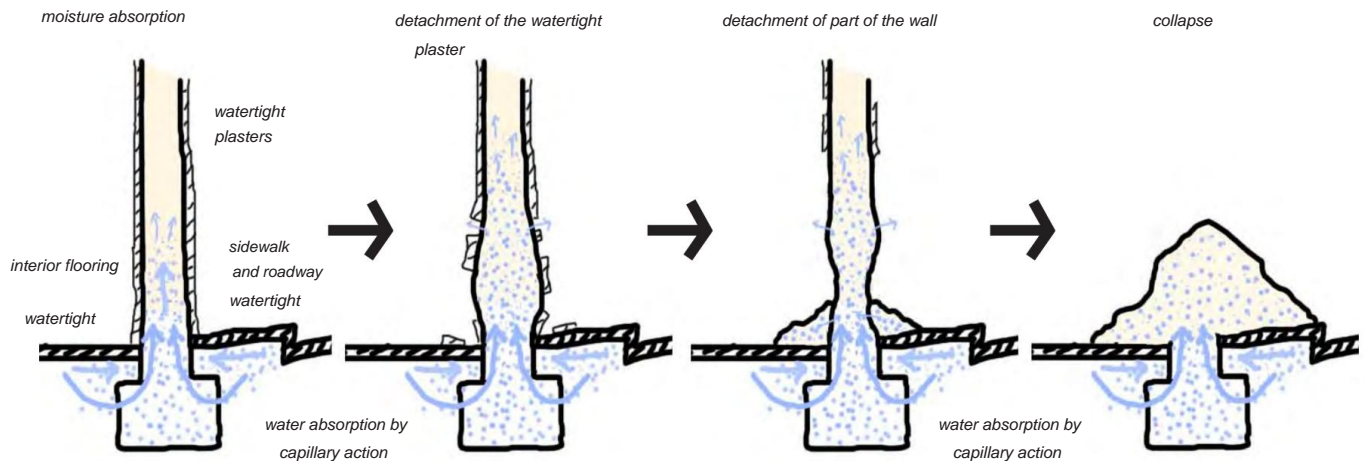
Moisture absorption scheme in an earth wall surrounded by impermeable surfaces (ES)

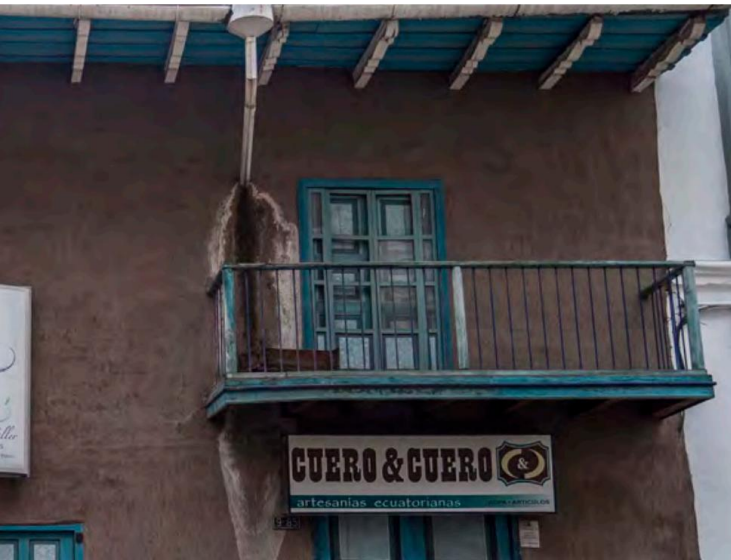
A faulty downpipe inside the wall is causing a water leak. (LA)

Once sealed, we should leave it inside the wall if it's not badly damaged; otherwise, we'll need to replace the damaged section, taking into account how it fits with the rest of the wall. Then we can install a new pipe outside the wall.

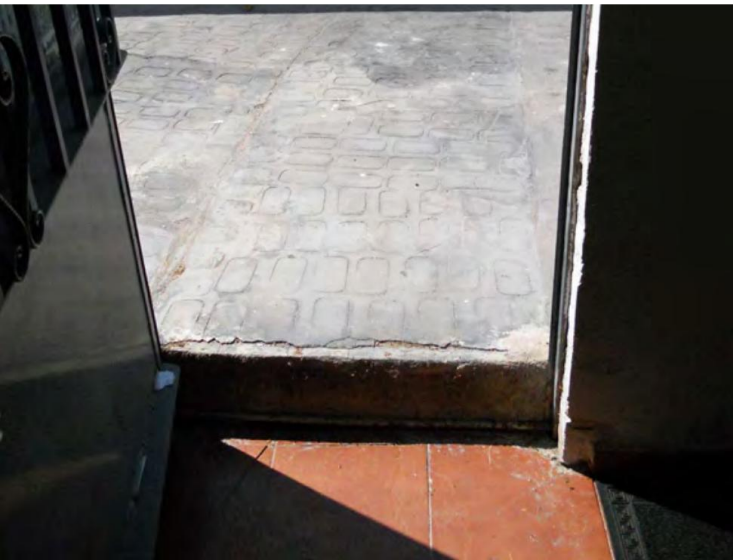
In that case, the foundation wall does not fulfill its function of protecting the base of the wall from the absorption of moisture by capillary action, and the wall is in a very vulnerable state at its most important and most demanded point: the base.

Street level rise (ES)

- The ideal solution would be to lower the level of the sidewalk.
- When this is not possible, another solution may be: 1. Shoring up the wall if necessary.
- 2. Remove the concrete or cement in the part next to the earth wall, in a strip at least 15 cm wide, and going down to the level of the foundation.
- 3. Place a fired brick vertically next to the earthen wall, using mud or lime mortar.
- 4. Fill the strip with gravel, with a thickness of 5cm, up to the level of the sidewalk.
- 5. Pour concrete or other material back onto the sidewalk.

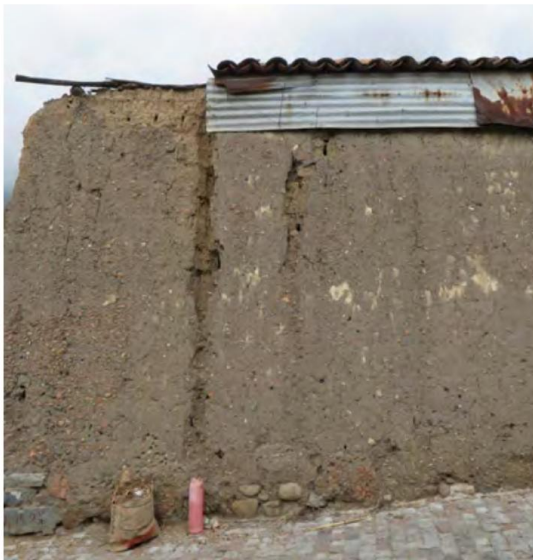
Due to the vertical load they bear, damp walls begin to swell laterally, eventually collapsing under their own weight. In the event of an earthquake, such a wall will most likely collapse.

Lack of foundations with signs of erosion at the base (ES)

1. Shoring up the wall, floors and/or roof.
2. Replace the adobe with stone or fired brick set in lime or cement mortar. This replacement is done in short sections, ranging from 50 cm to 1 m in length. We will begin by replacing half the thickness of the wall on the exterior side.
3. Replace the other half of the wall thickness on the inside side, always in sections and taking into account the bond.
4. If the wall is very thin, replace it at once by shoring up the top part.

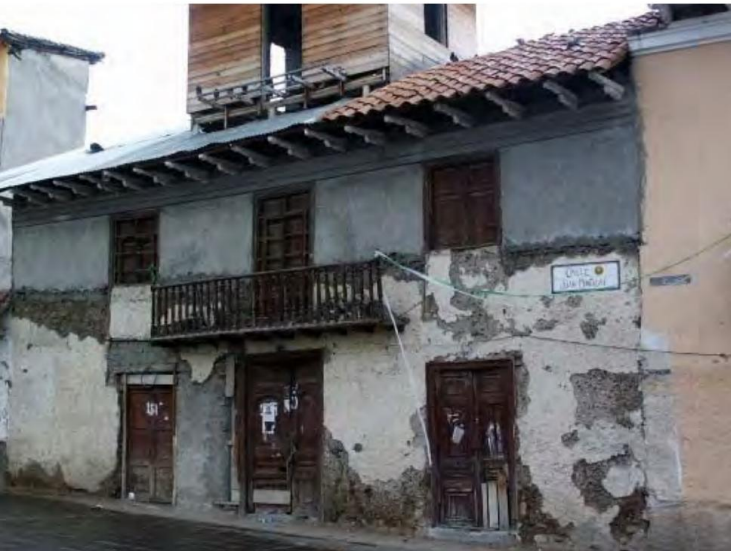
Moisture trapped in the wall beneath the watertight plaster tends to evaporate, especially in hot weather. Unable to escape the wall, the water condenses on the surface between the plaster and the wall, causing the earthen wall to weaken and crumble, and the plaster to detach.

Adobe wall with detachment of the watertight plaster (LA)

- First layer of mud and straw, 2-3 cm thick. (depends on the original layer)
- Plaster finish, 3mm thick, with an average proportion of: 1 part of very fine kaolin-type soil and 1 part of shredded horse manure.

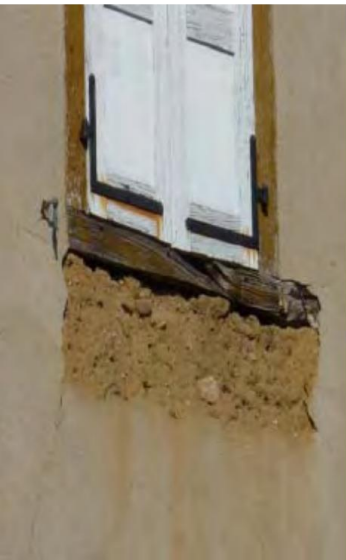
Water infiltration under the sill (SM)

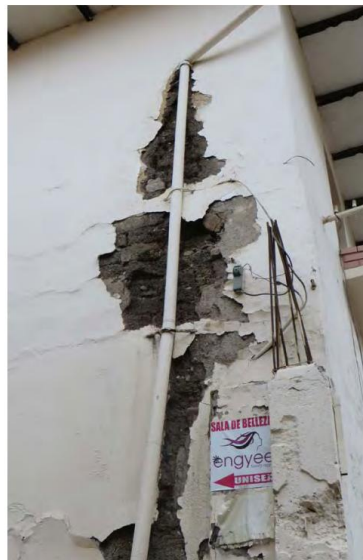
It is also possible to have defective pipes or downpipes installed outside the walls, in which case the consequences will be the same: loss of material in the wall and its weakening.

Defective downpipe (ES)

In case of dampness due to a poorly designed drain, we will have to replace the pipe with one that reaches the floor, filling the degraded parts of the wall with a mixture of earth and straw and replastering it with a non-watertight mortar.

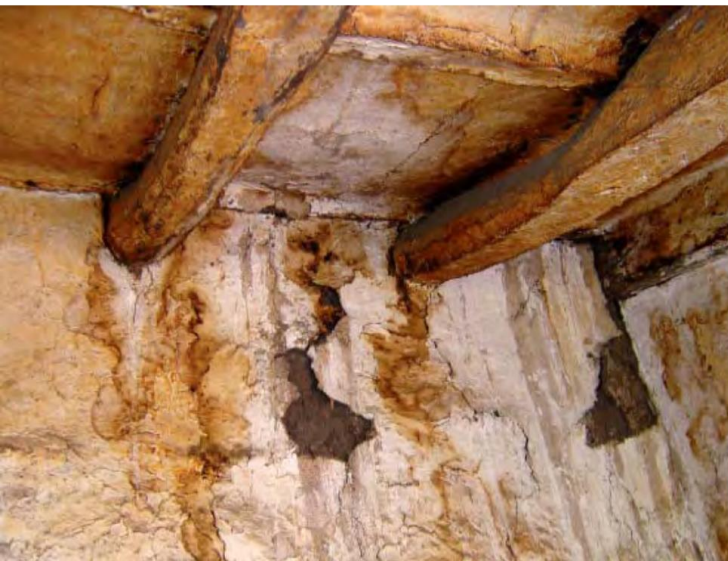
The presence of short eaves or deficiencies in the roof increases the probability that rainwater will penetrate the wall, generating undermining and erosion of the materials, which facilitates the presence of cracks and decreases the resistance of the structural system.

Water infiltration from the roof (DP)

If the cause of the dampness problem is leaks, it is necessary to repair the roof at the affected points by replacing broken tiles, doubling up any damaged wooden structural elements, and giving the roof general maintenance.

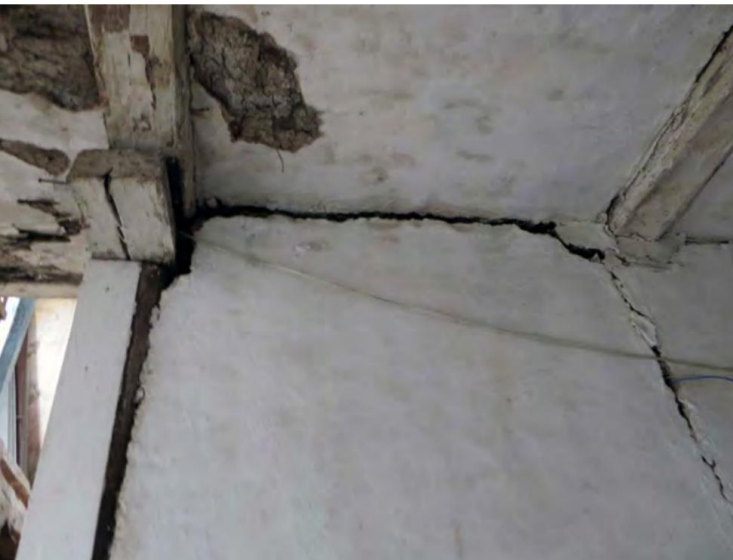
Cracks caused by crushing of part of the wall due to localized dampness in a bathroom (ES)

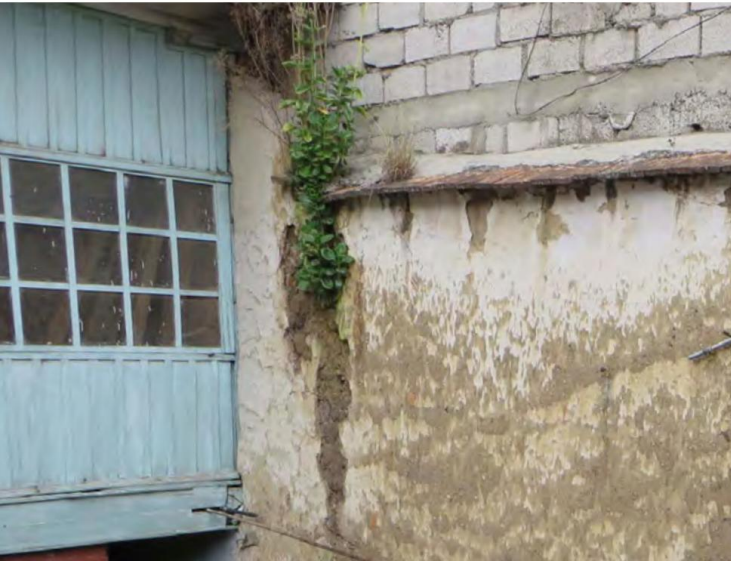
Adobe wall with a defective roof, showing dampness and plants, before and after the intervention, Casa Otorongo. (EC, ES)

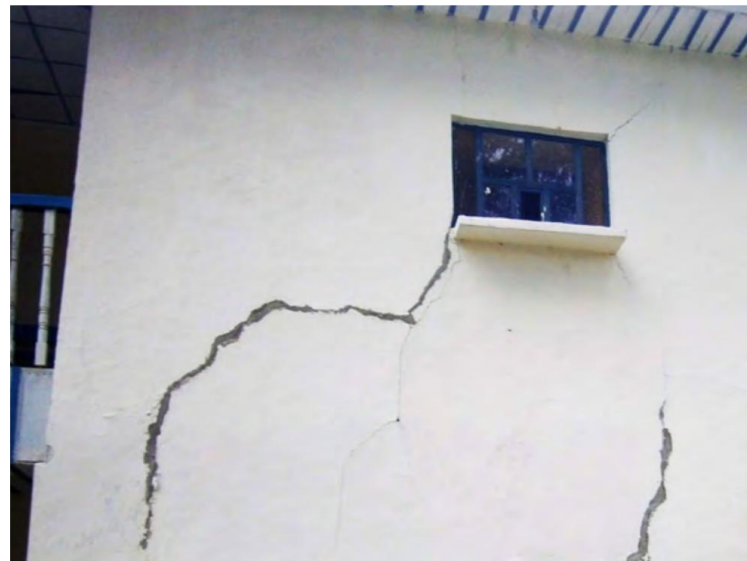
Foundation settlement cracks (upper crack) (LA)

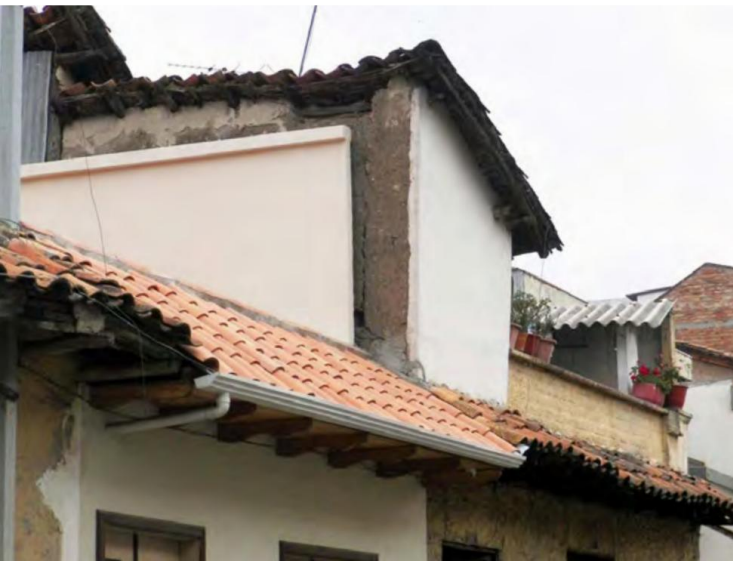
Collapse of the upper floor of a building. (EC)

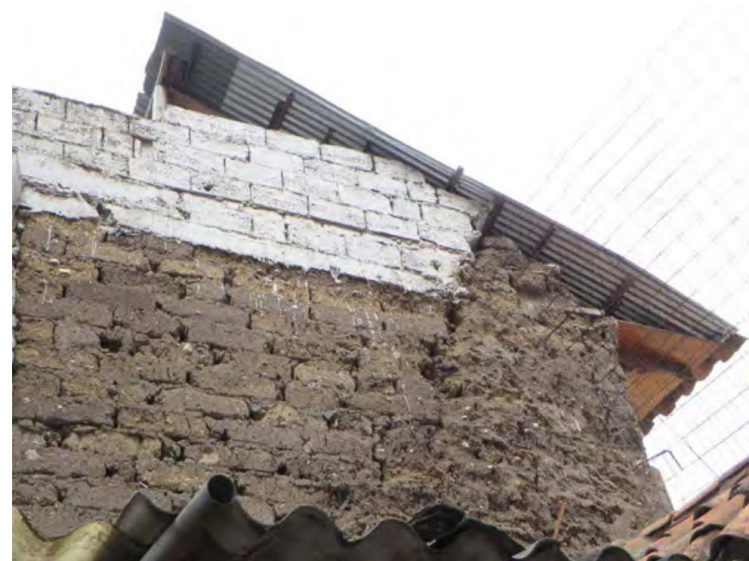
A vertical crack indicates that the two walls are separating. (ES)

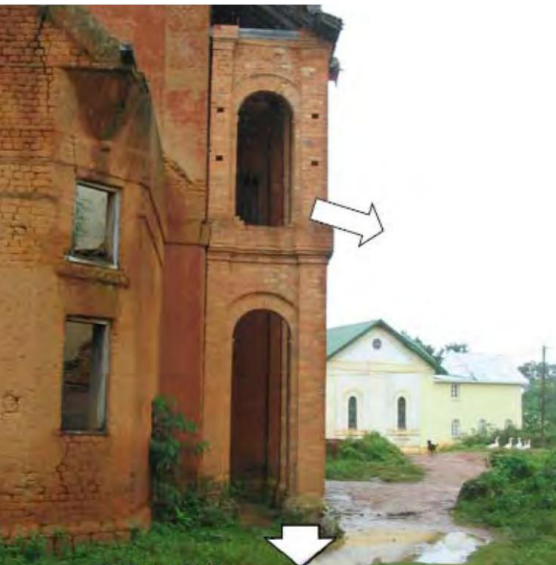
Collapse due to soil settlement (with trapped water) in Madagascar, (YE)

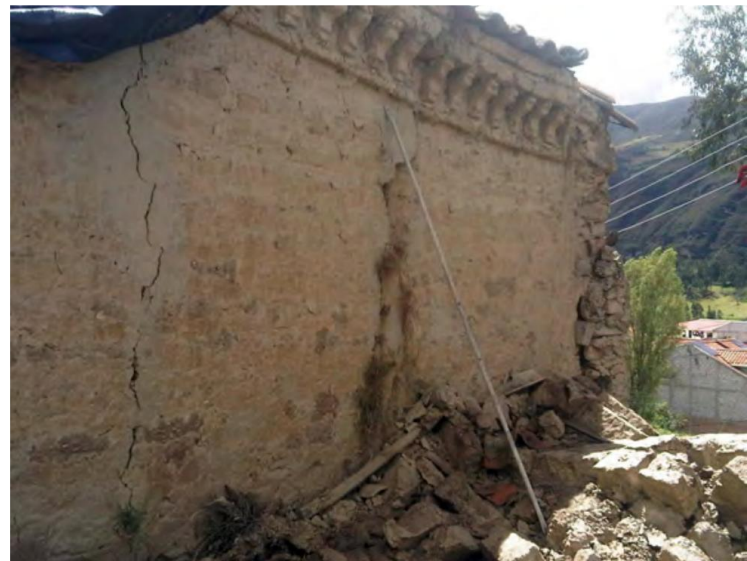
Vertical settlement cracks, Sigsig Cemetery (LA)

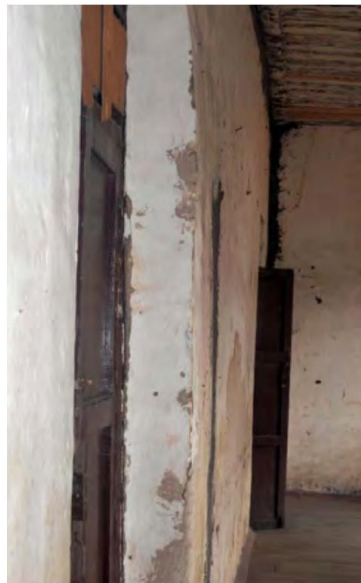
*Buckling due to leakage
Rainwater dripped onto a
wattle and daub wall. "Good
Shepherd" Convent (MCA)*

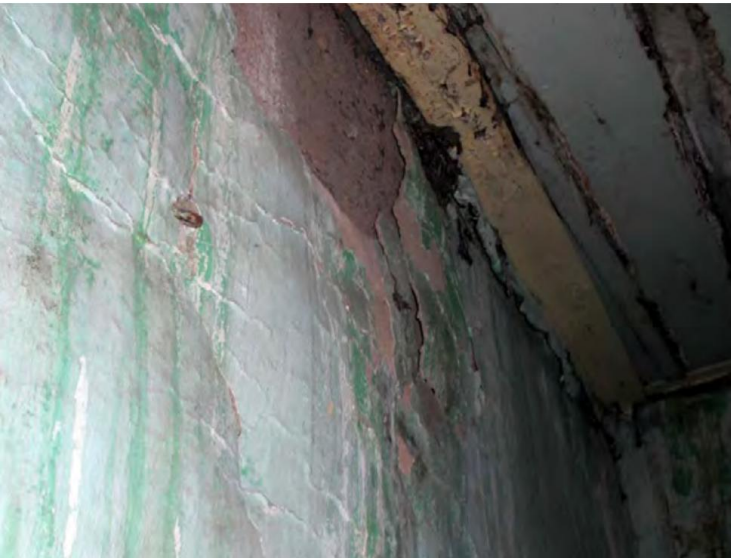
Wall deformation due to water infiltration (MCA)

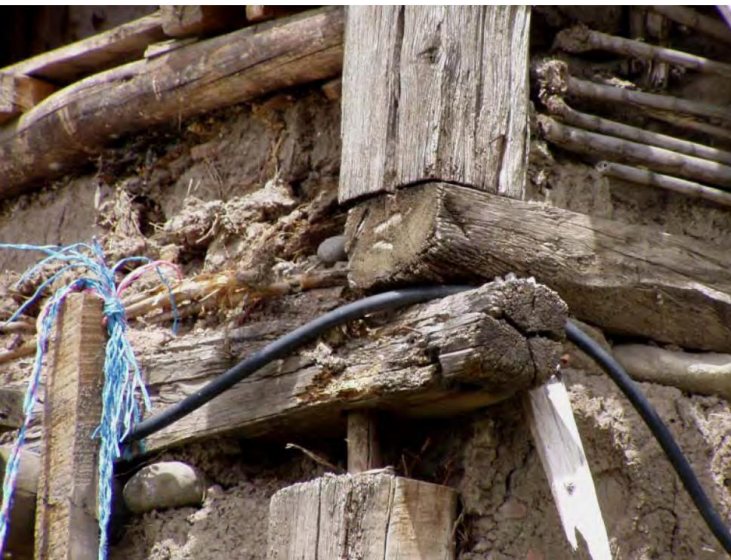
Wattle and daub structure deteriorated by moths (LA)

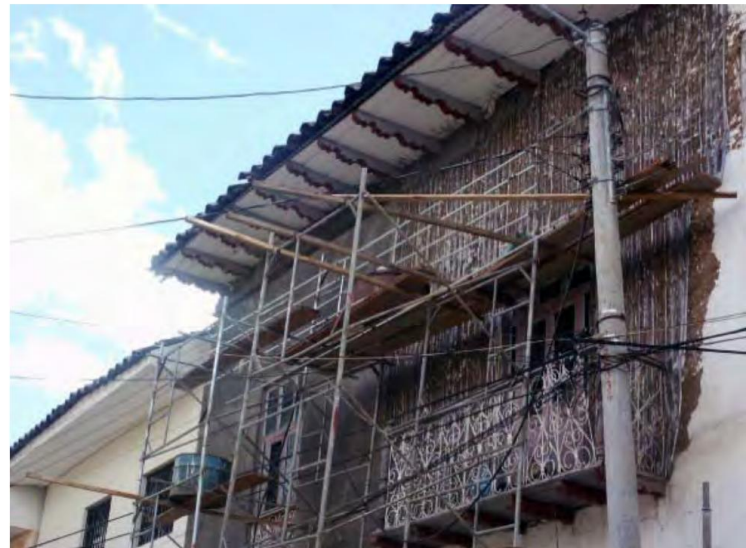
Cement-based plasters, which do not allow water to evaporate, cause moisture problems in the wall. (LA)

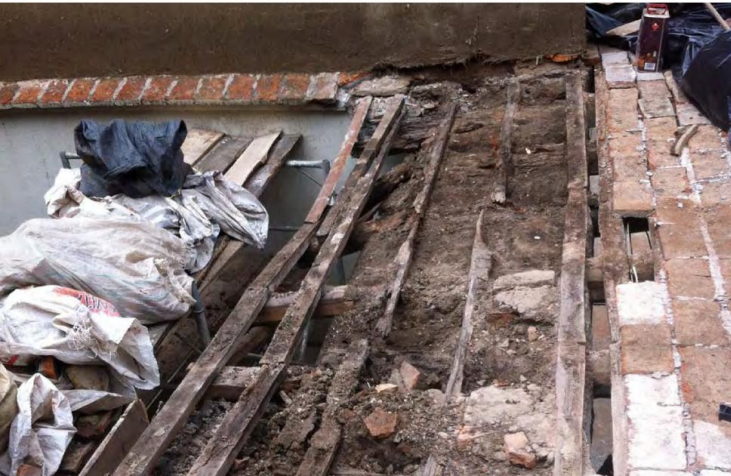
- The wooden beam structure of the brick terrace shows dampness and rot on the adobe wall.

The two layers of brick and the support strips were removed, the condition of the beams was checked, and those that were rotten at their ends were reinforced. Parallel beams were then installed and secured with bolts to minimize damage to the adobe walls.

The first layer of brick was then laid, followed by a sheet of asphalt for waterproofing, and then the second layer of brick.

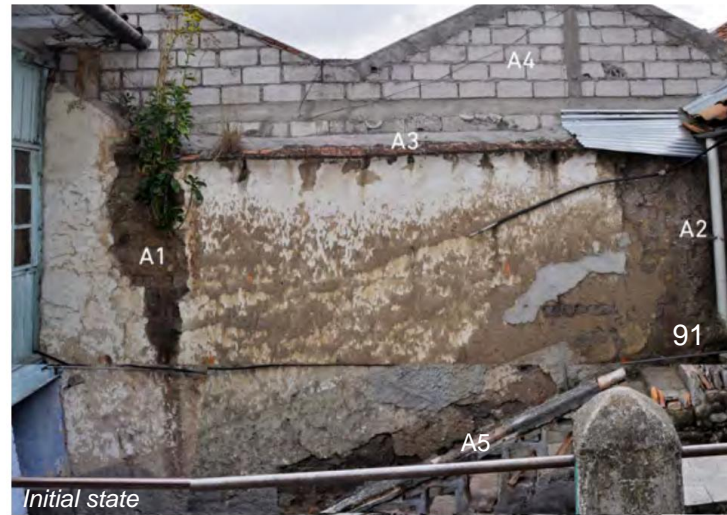
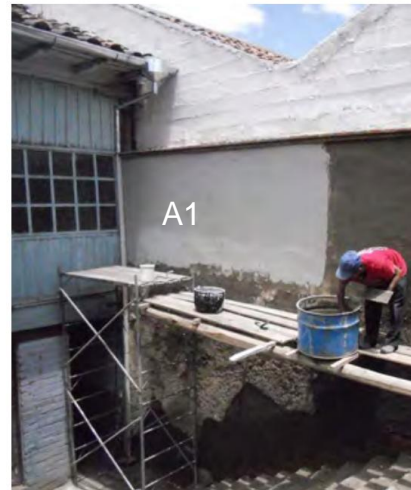
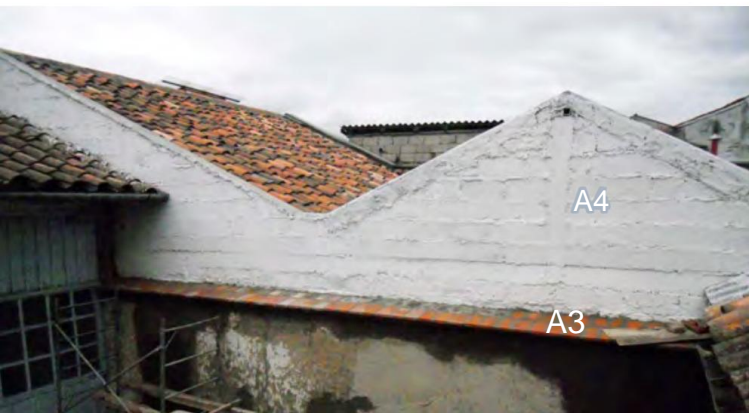
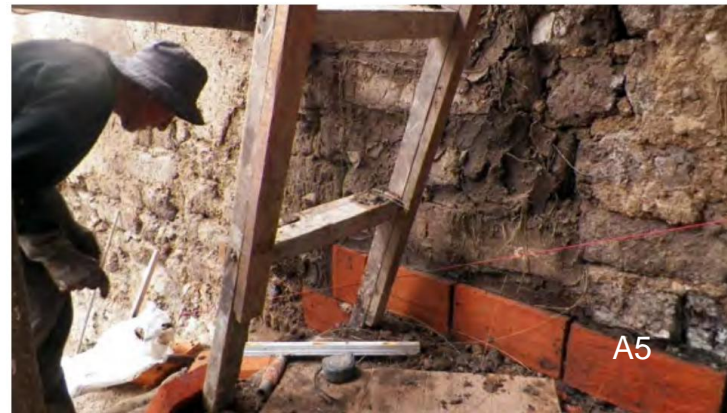
PARTY ADOBE WALL IN COURTYARD A1. *Detachment of plaster and growth of vegetation inside the wall* >> Removal of vegetation, repair of the mud and straw plaster, plastering and lime finish

A5. *Base of the wall not protected from water* >> Creation of a protective layer in masonry bricks.

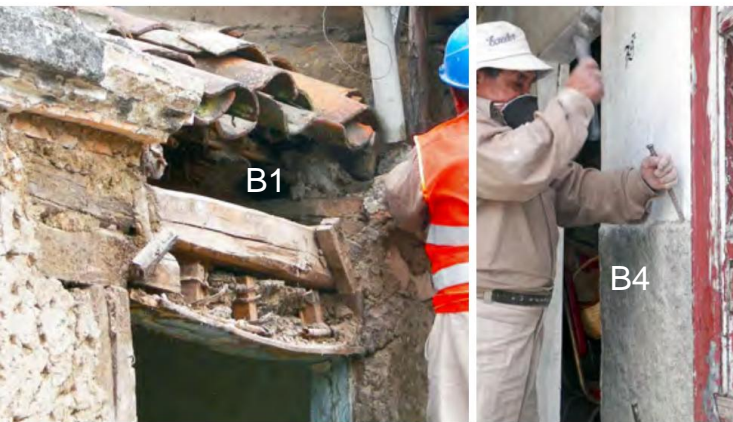
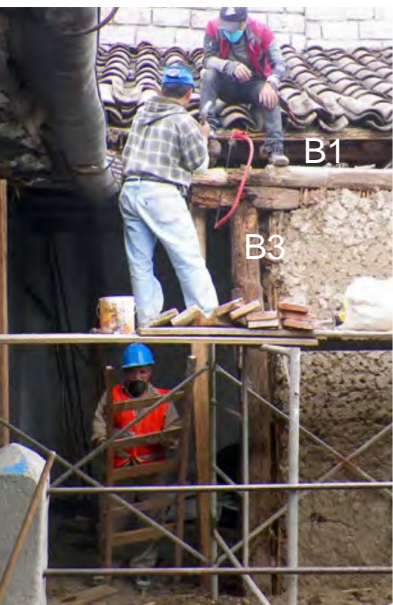
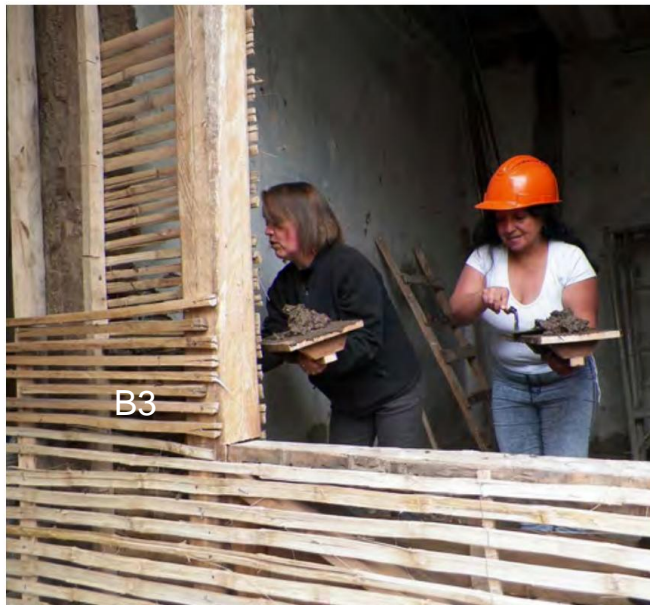
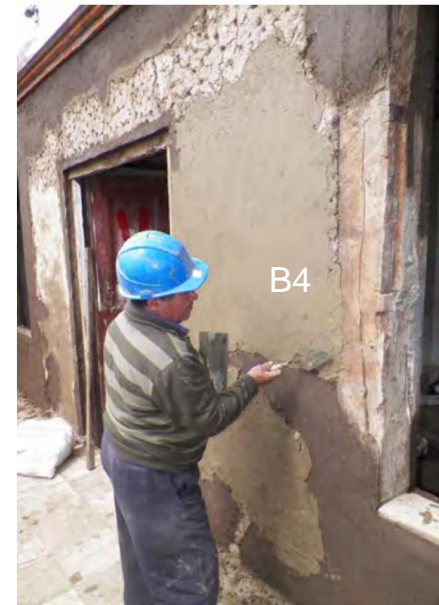
B4. Watertight and deteriorated plaster >> Replacement of the watertight plaster with mud and straw plaster and stucco (mixture of whitish earth and horse manure).

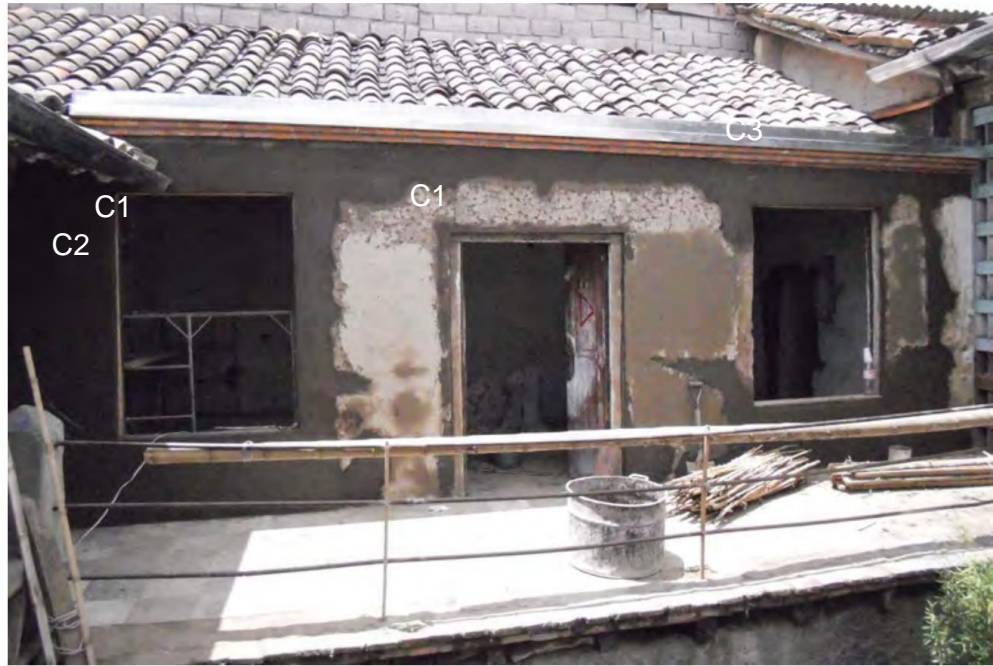
C1. Leaking brick channel in the wattle and daub wall and defective zinc channels in the gallery and in the roof of the rear bay >> Construction of brick cornice and replacement of the channels.

C3. Terminal pair of the rear bay cover rotten (initial state on previous page) >> Pair replacement.
